**Region 9 Enforcement Division
75 Hawthorne Street
San Francisco, CA 94105**

Inspection Date(s):	9/30/2015		
Time:	Entry: 8:45	Exit: 10:30	
Media:	Water		
Regulatory Program(s)	Clean Water Act NPDES /CAFO Dairy		
Company Name:	Northview Dairy		
Facility or Site Name:			
Facility/Site Physical Location:	10601 Riverside Drive, Ontario CA		
Geographic Coordinates:			
Mailing address:	13191 Haven Avenue, Ontario, Ca, 91761		
Facility/Site Contact:	Daryl Koops	Title: Operator	
	Phone: [REDACTED]	Email:	
Facility/Site Identifier:	NPDES CAG018001 / Order R8-2013-0001, General waste discharge requirements for CAFOs (dairies and related facilities)		
NAICS:	112120 Dairy Cattle and Milk Production		
SIC:	0241 Dairy Farms		
Facility/Site Personnel Participating in Inspection:			
Name	Affiliation	Title	Email
Daryl Koops		Operator	
EPA Inspector(s):			
John Tinger	EPA	Engineer	Tinger.John@EPA.gov
Federal/State/Tribal/Local Representatives:			
Edward Kashak	WRCB-R8	Engineering Geologist	ekashak@waterboards.ca.gov

SECTION I – INTRODUCTION

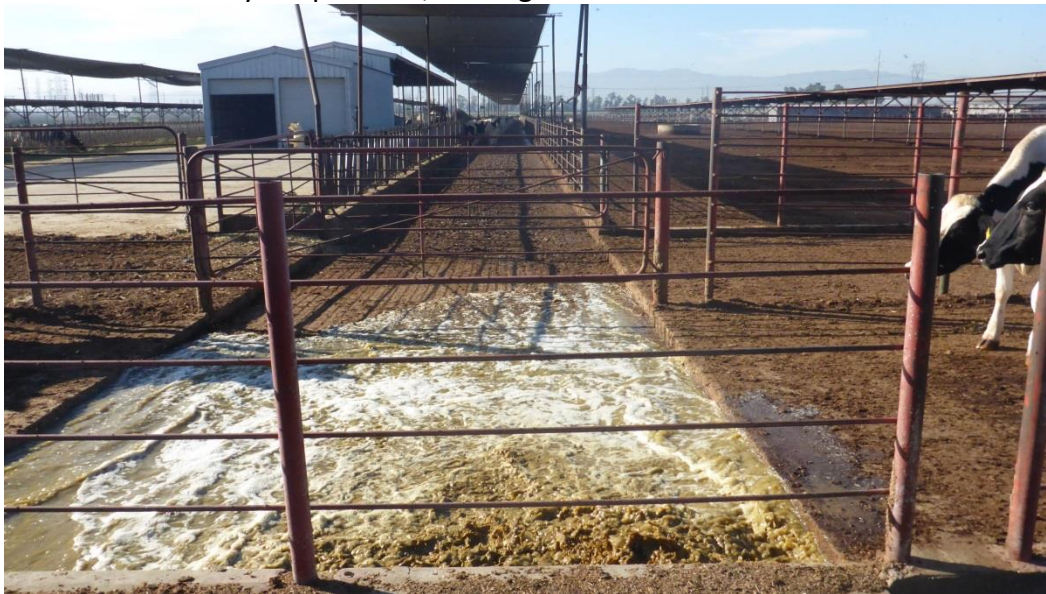
The facility operates a “Flush Alley System”. Washwater from the milk barn is transferred to a 20,000 gallon (estimate) storage tank. The washwater from the tank is then used to flush the alleyways to clean manure from the concrete areas of the corrals (see photos 3-5). Alleyways are flushed once per day. The alley washwater flushes to the treatment lagoon (photo 6). At the lagoon, wastewater is pumped from the lagoon through a mechanical screen (photo 7). Solids from the screen are settled in a bin overnight, and water decanted back into the lagoon (photo 8). The solids are stacked in the central area where some additional drying occurs prior to hauling off-site (photo 9).

Photo 3: Flush alley in operation, looking south

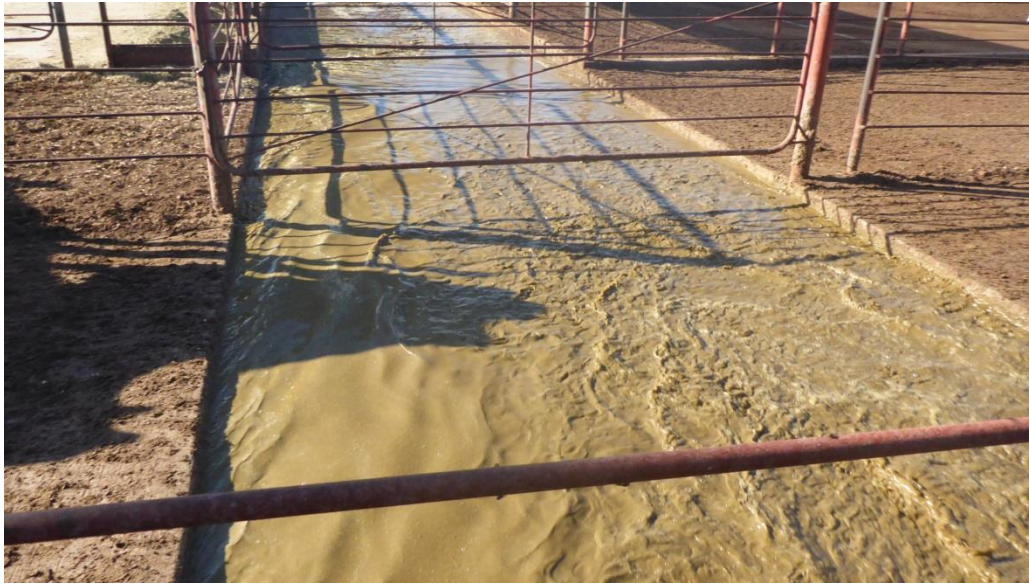
Photo 4: Flush alley

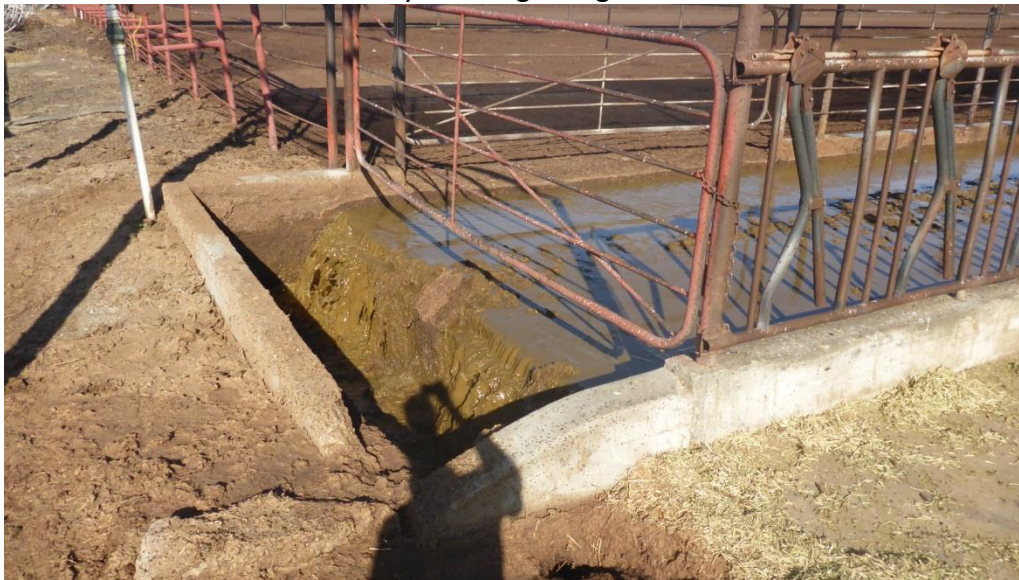
Photo 5: terminus of flush alley draining to lagoon

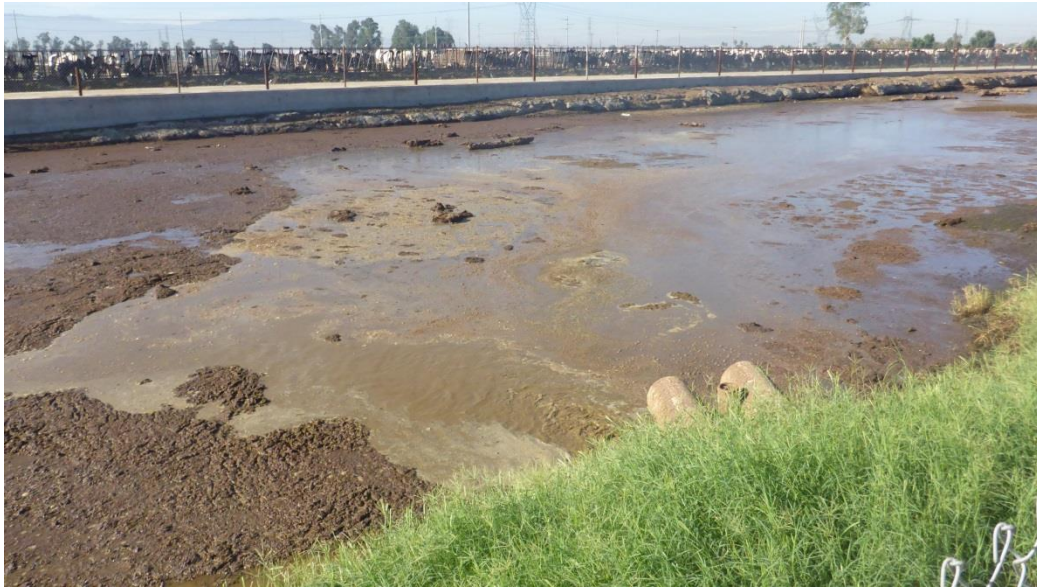
Photo 6: Treatment Lagoon, looking south

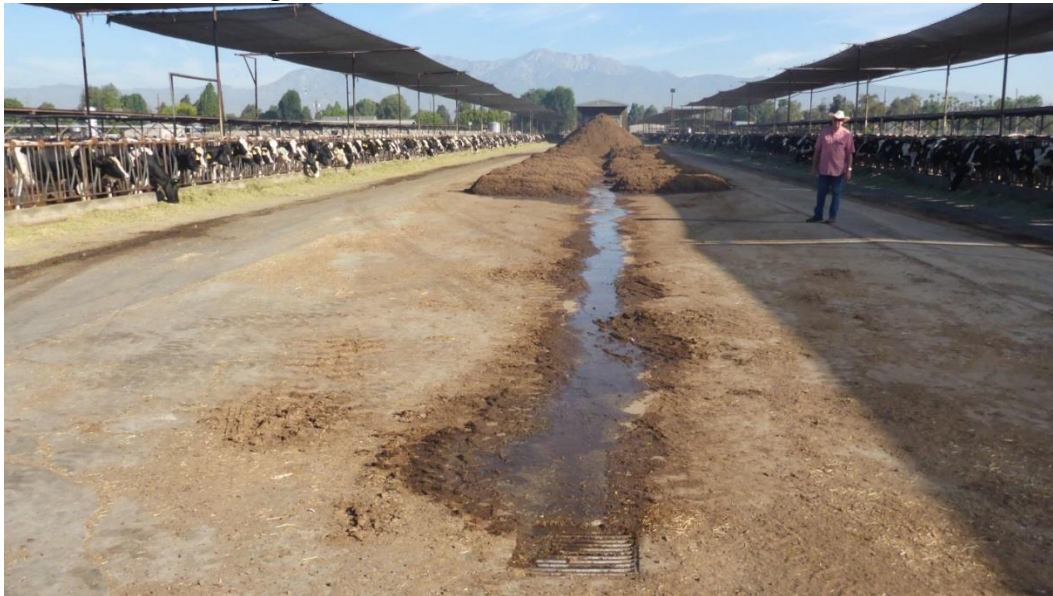
Photo 9: solids storage after removal from decant bin

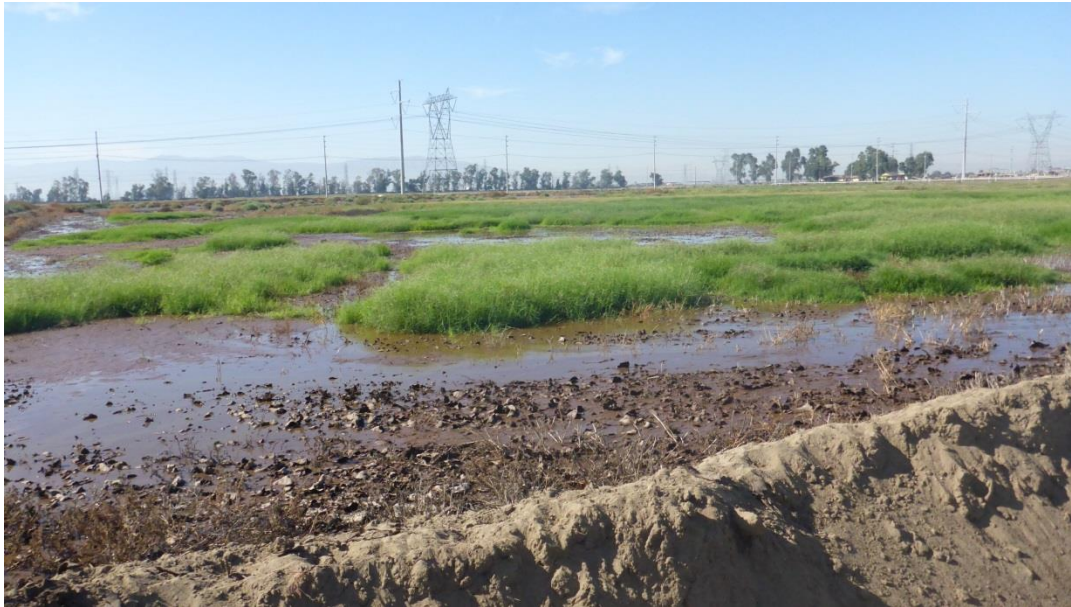
Water decanted from the lagoon is pumped to one of two bermed disposal areas in the south eastern area of the facility (photo 10). The operator alternates disposal to the bermed areas. When one area becomes full of solids, the operator will send washwater to the other bermed area while the operator removes solids and then disks the area to promote infiltration.

The bermed areas at the south of the facility were dry.

Photo 10: Bermed disposal area in southeast corner of facility

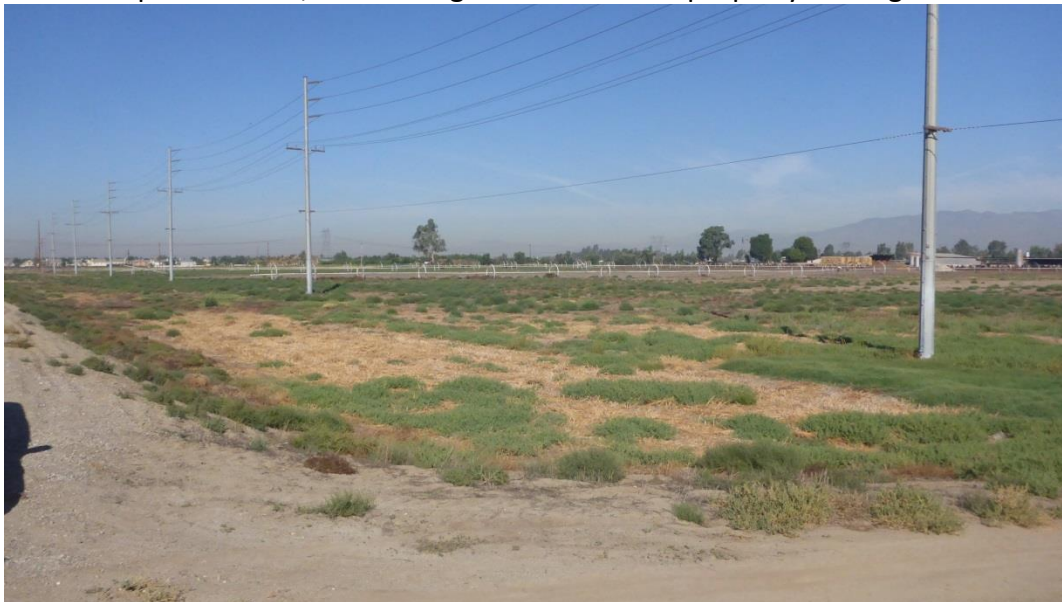
No evidence of significant rodent damage, erosion, or excess vegetation along berms was observed.

Photo 11: pasture area, berm along southern end of property looking northwest from spillway.

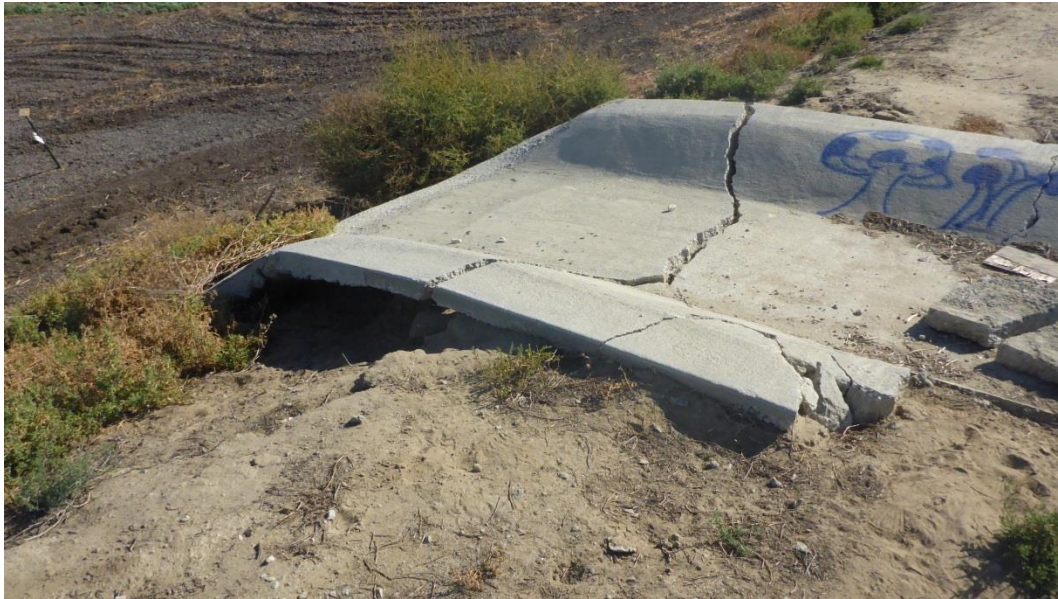
- The storage structure spillway was severely cracked and subject to undercutting erosion.

Storage structure Spillway concrete was severely cracked and undercut due to erosion.

- The spillway was not properly maintained, which may have the potential to affect the integrity of the storage structure in the event of overtopping the constructed spillway.

Photo 12: concrete spillway in disrepair

If not, list structures missing or deficient: Spillway in need of repair.
